II. 2014 Additions to the Historic Resource Survey

This section of the 2014 Historic Resource Survey includes 8 sites that were not previously surveyed. The consultant, Nancy Burgess of Preservation Consulting, visited each site, completed an inventory form, consulted County and City records, and evaluated eligibility as a City Historic Landmark. The following table is a summary of each of the newly surveyed sites and the results of the survey. Included is a copy of each Inventory Form, photos of the site, and in some cases a copy of the building plan. This section is organized by street address.

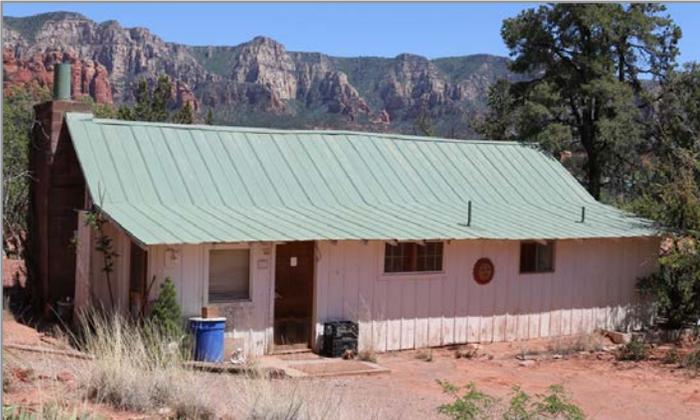
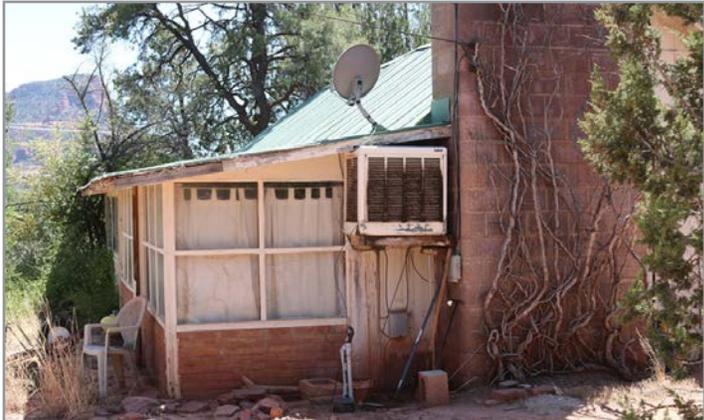
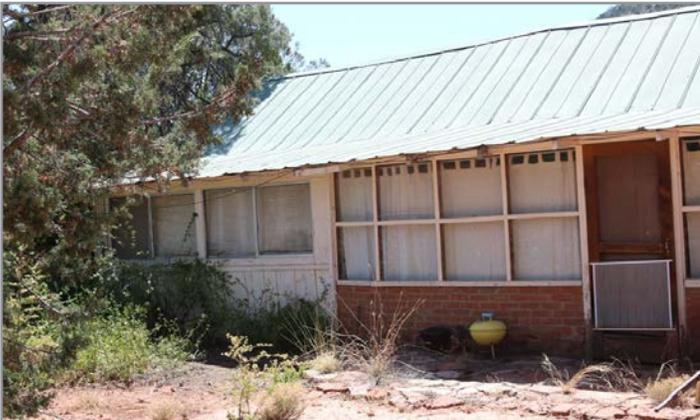
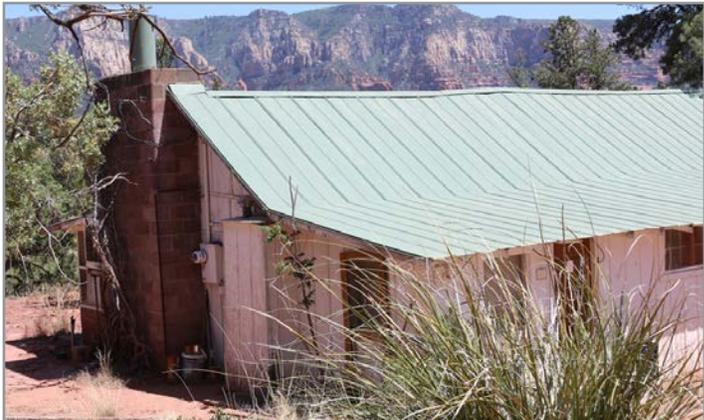
335 Brewer Road
Site # 285
May 2014

Describe: Structural issues mainly due to foundation deterioration, with loose stones, crumbling concrete and missing areas, particularly in the rear where the porches have been enclosed; roof ridge is highest in the center, sloping slightly to the ends of the side gabled roof which probably indicates foundation problems. According to Coconino County records, the primary value of this property is in the land.

Changes/additions to the building, replacement of almost all of the windows, and, most significantly, the porch enclosures which have altered the footprint of the house and completely enclosed the original façade of the building, along with the lack of maintenance have impacted the building to the extent that the building has lost its historic context and integrity.

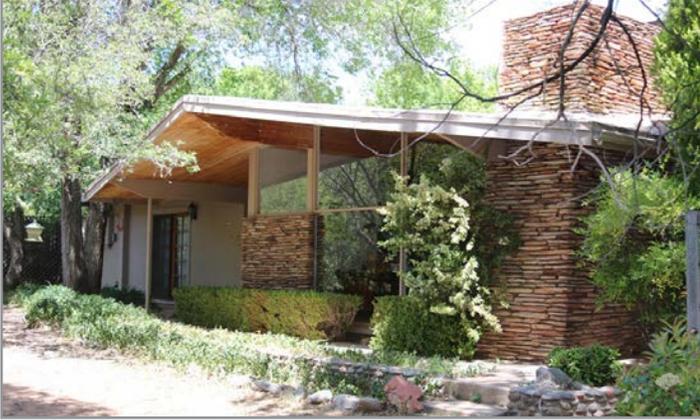
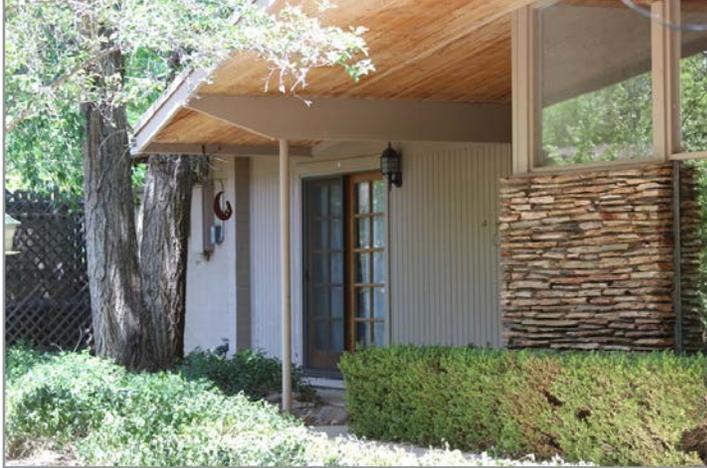
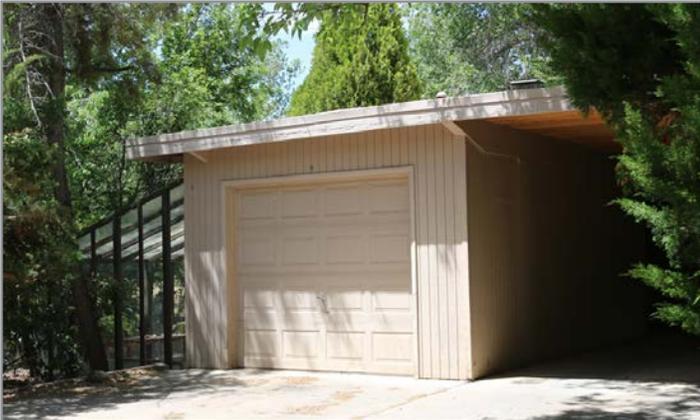
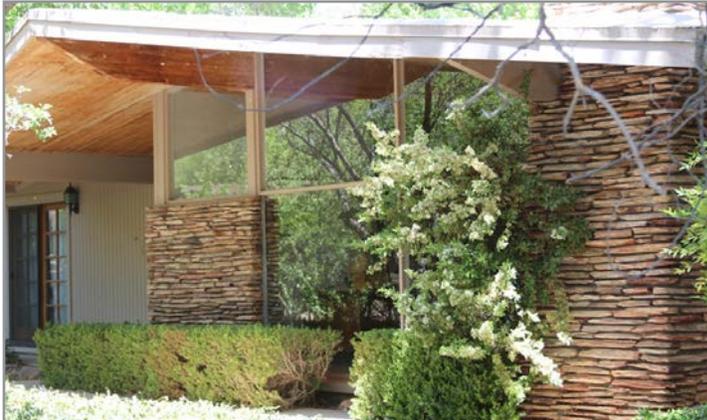
55 Copper Cliffs
Site # 286
May 2014

Describe: Most of this building is not visible due to fencing and tall plantings; however, there are no apparent structural issues.

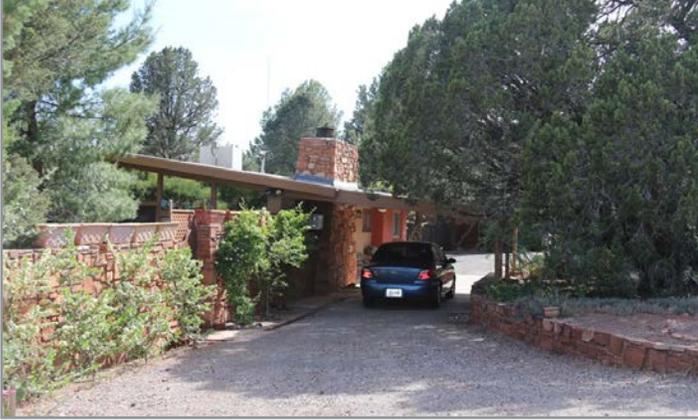
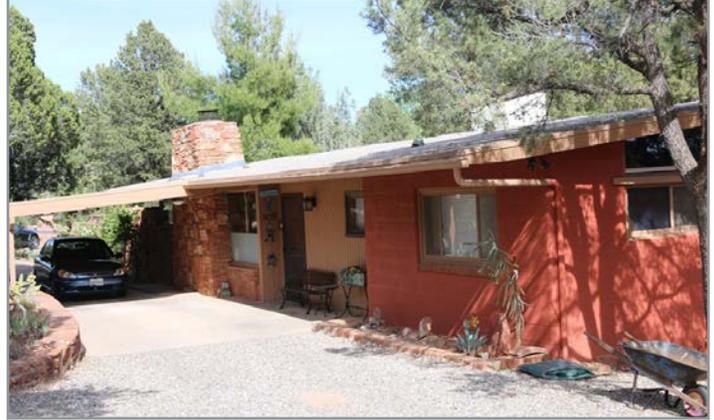
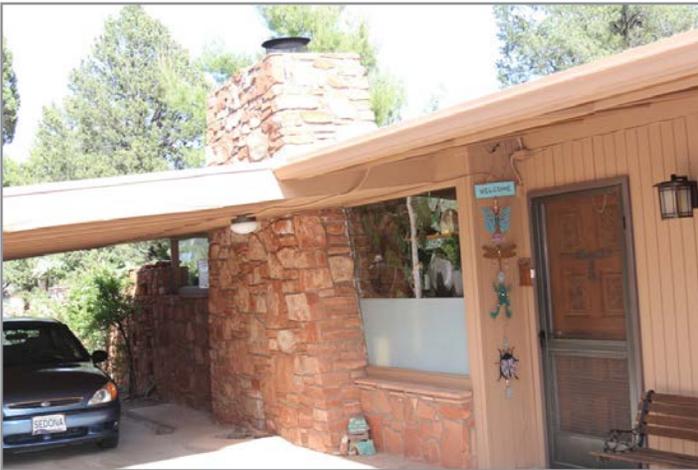
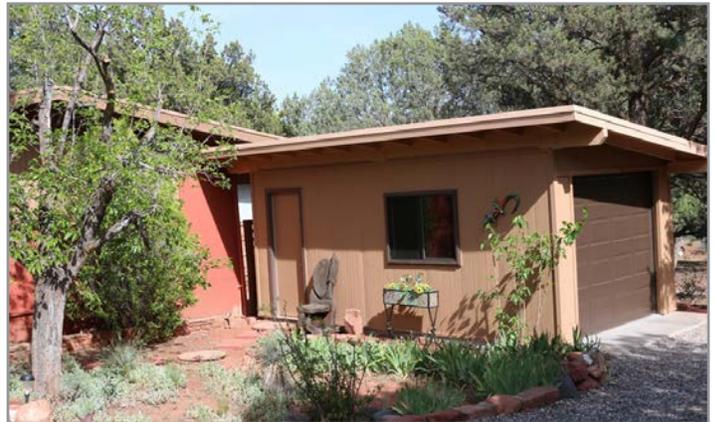
55 Kachina
Site # 287
May 2014

Good <i>(well maintained, no serious problems apparent):</i>	X	Poor <i>(major problems; imminent threat):</i>	
Fair <i>(some problems apparent):</i>		Ruin/Uninhabitable:	
<i>Describe:</i> No apparent structural issues.

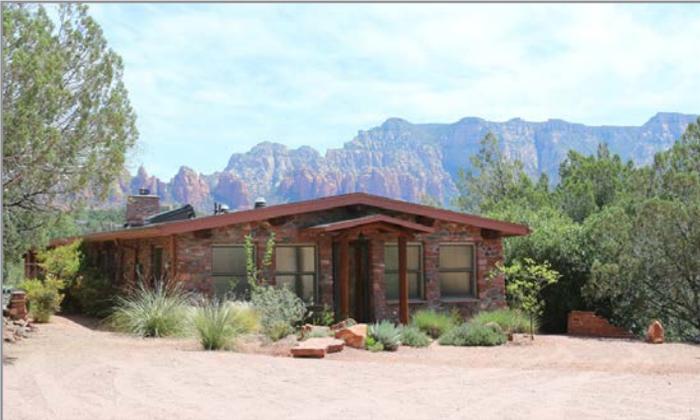
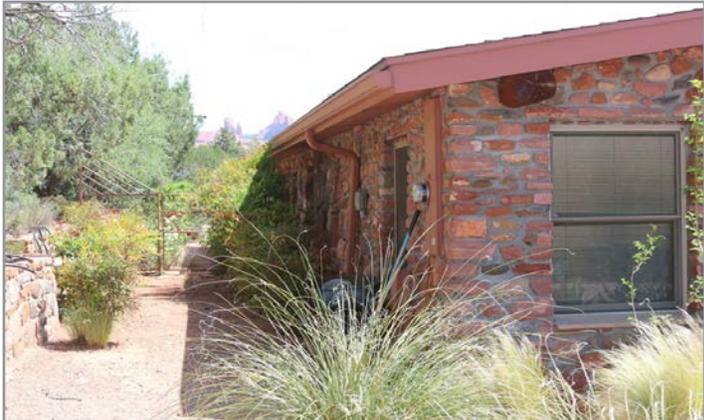
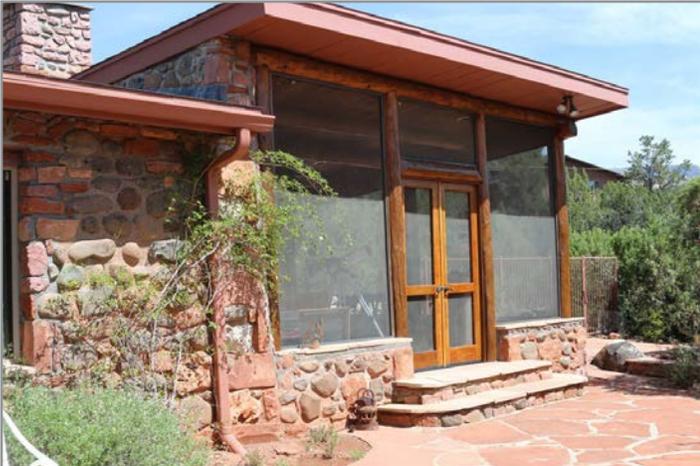
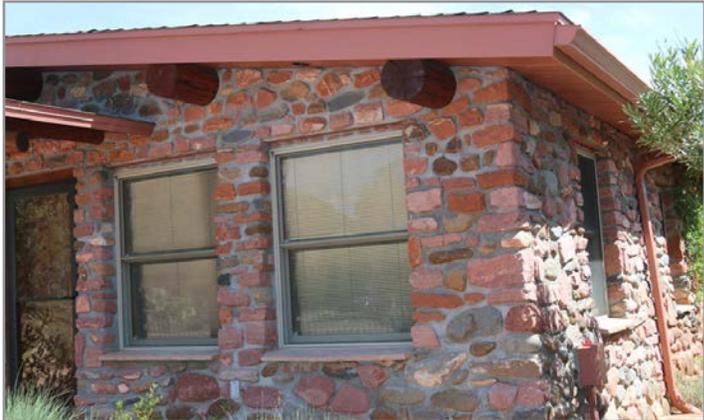
Site # 281

Good <i>(well maintained, no serious problems apparent):</i>	X	Poor <i>(major problems; imminent threat):</i>	
Fair <i>(some problems apparent):</i>		Ruin/Uninhabitable:	
<i>Describe:</i> Structural condition is excellent and house and grounds are very well maintained; no structural problems observed.

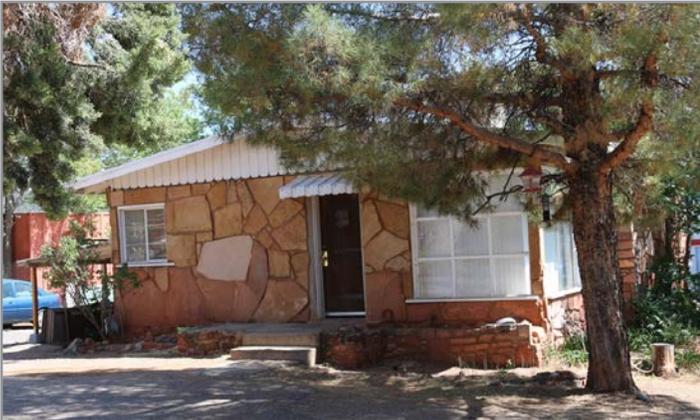
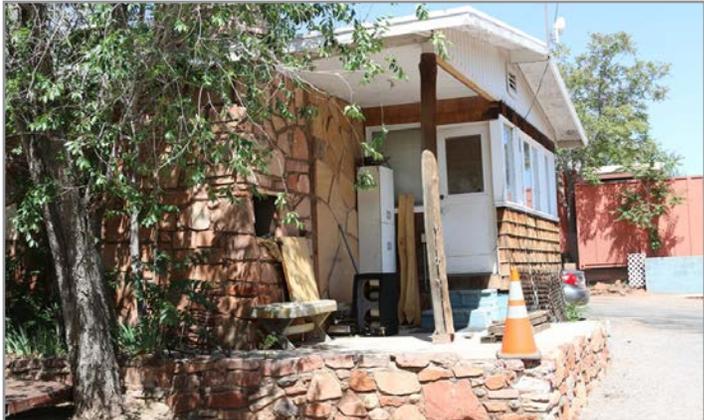
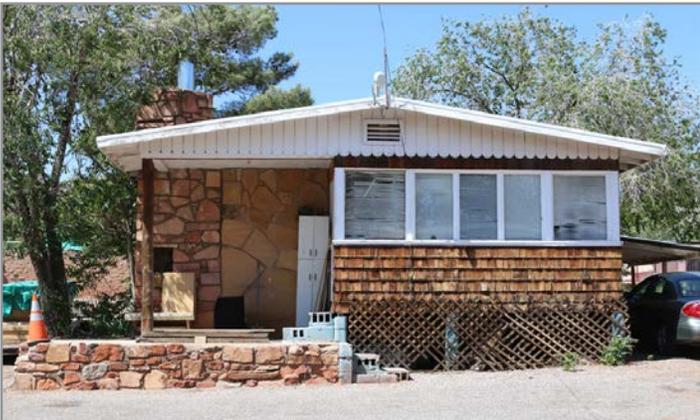
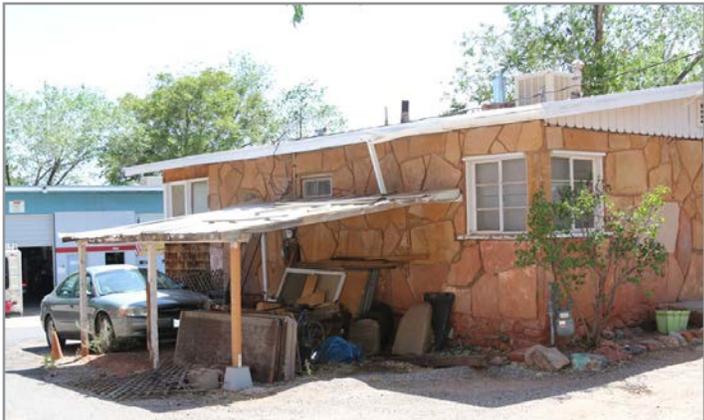
2035 Yavapai
Site # 284
May 2014

A rear sleeping porch or sun porch has been enclosed with banded, fixed pane windows and wood shingle siding below the windows. Windows have mostly been replaced with a variety of types. A lean-to, shed-roofed carport has been added to the east side of the building and an aluminum awning has been added over the non-original front door.

Although this building represents a "modern" construction type for the time period for Sedona (1951), the setting in an industrial area, changes/additions to the building, replacement of all but 2 windows and the lack of maintenance have impacted the building and setting to the extent that the building has lost its historic context and integrity.
